# Manhole Inspection Summary

Manhole # S35S\_\_069MH

Insp Date: **8/26/08 2:47 PM**

**Location** Address: **1229 wall st**

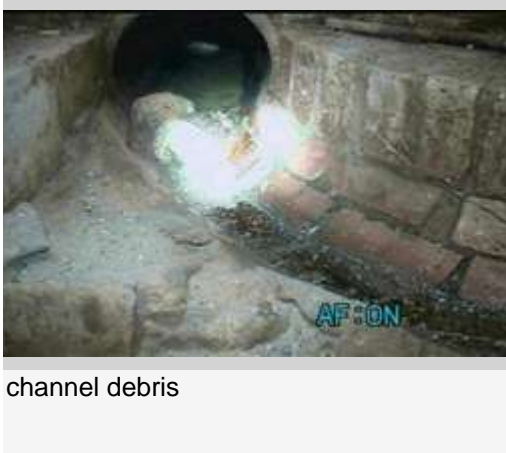
misc

bench debrtis

channel debris

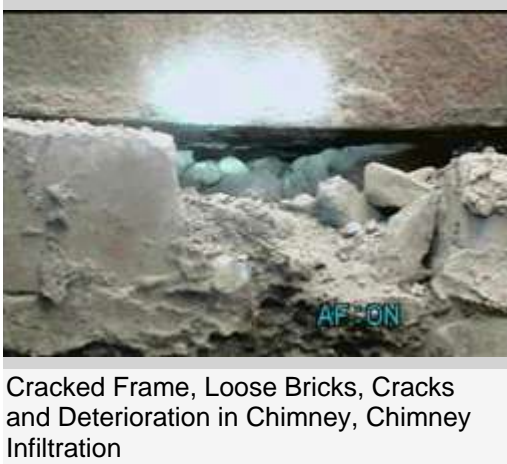
Defect 3

Condition: ☐ Sound ☒ **Cracked** ☐ Leaks

Condition: ☐ Sound ☒ **Cracked** ☐ Root Intrusion ☒ **Loose Brick** ☒ **Deteriorated**

Infiltration: ☐ None ☒ **Joint** ☒ **Cracks** ☐ Mortar ☐ Roots ☐ Wall

Cracked Frame, Loose Bricks, Cracks and Deterioration in Chimney, Chimney Infiltration

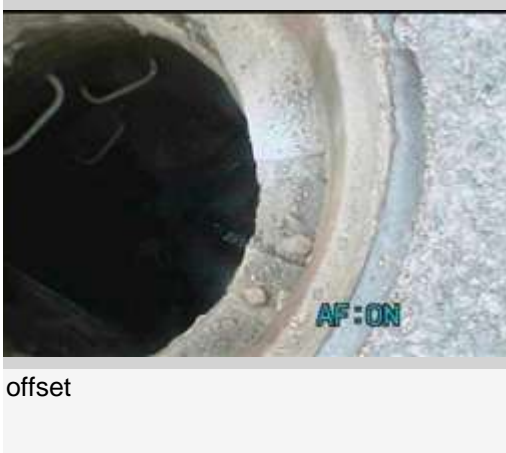
Defect 2

Offset: **3** (in.)

offset

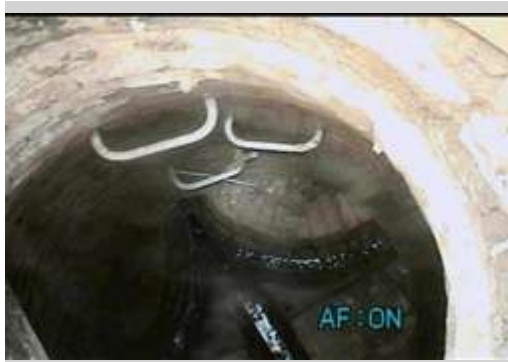
### Defect 1

Count: **4** Missing: **1** ☒ **Corroded**

steps

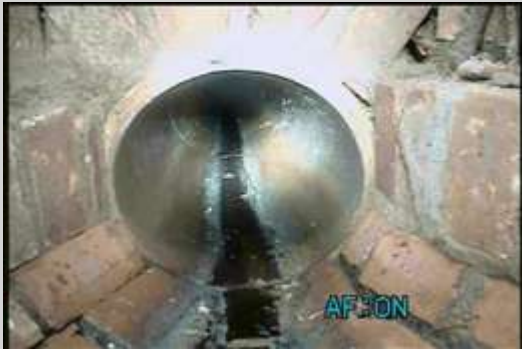
12 O'Clock Outflow

8 in. Circular Gravity Sewer  
Pipe Out @ 12 O'Clock

Invert Depth: **9.40** (ft.) Flow Characteristics: **Fast**

Infiltration: **None** Pipe Seal Cond: **Unknown**

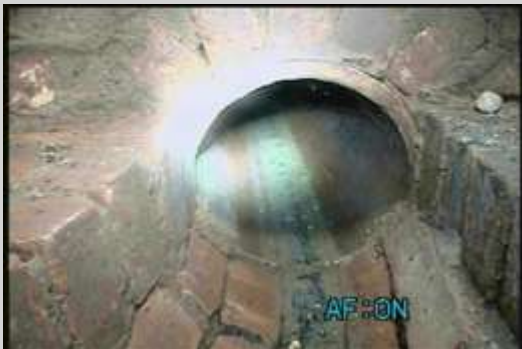
3 O'Clock Inflow

8 in. Circular Gravity Sewer  
Pipe In @ 3 O'Clock

Invert Depth: **9.25** (ft.) Flow Characteristics: **Slow**

Infiltration: **None** Pipe Seal Cond: **Unknown**

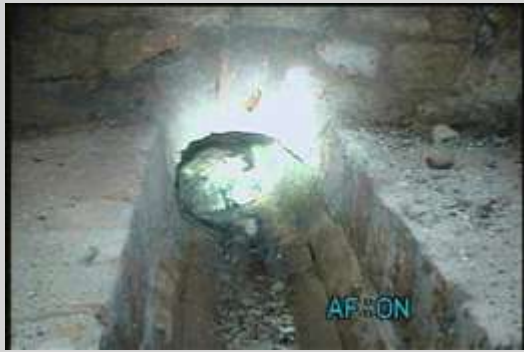
6 O'Clock Inflow

8 in. Circular Gravity Sewer  
Pipe In @ 6 O'Clock

Invert Depth: **9.25** (ft.) Flow Characteristics: **Fast**

Infiltration: **None**

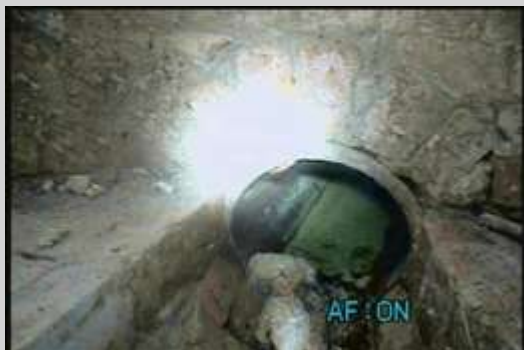
9 O'Clock Inflow

8 in. Circular Gravity Sewer  
Pipe In @ 9 O'Clock

Invert Depth: **9.20** (ft.) Flow Characteristics: **Slow**

Infiltration: **None**
